Trophy Club Storm Water Master Plan – Phase I

Town of Trophy Club

FREESE AND NICHOLS, INC.
4055 International Plaza, Suite 200
Fort Worth, Texas 76109
817-735-7300
TRO11171

DRAFT

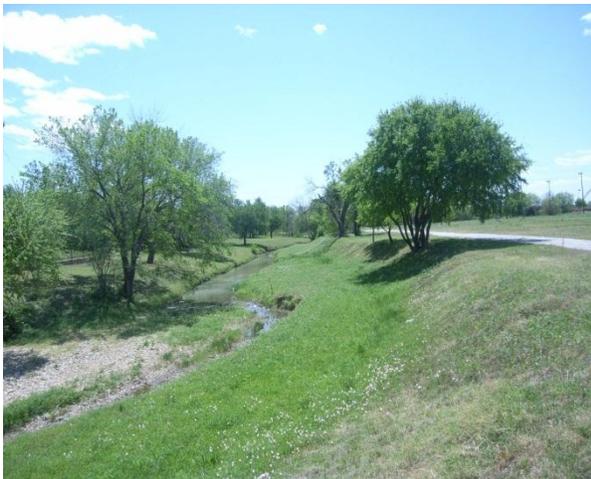
According to information from Town Staff, Trophy Club Drive has been overtopped on several occasions, requiring barricades to prevent traffic flow during storm events. Calculations indicate that the road currently offers 2-Year return event flood protection and may act as a low-water crossing during larger return event storms due to depth of inundation. For 5-Year return event flows, the road is expected to be overtopped by approximately 1.8 feet. This depth increases to an expected 6.2 feet for 100-Year return event flows. Currently the channel flows north from Highway 114 through 3-10'x8' (10 feet wide by 8 feet high) reinforced box culverts (RBC) at Trophy Club Drive and continues north through the golf course to its confluence with Lake Grapevine as shown on Figure 1. Visual evidence indicates that erosion along the banks and sedimentation on the upstream side of the culverts has partially blocked conveyance through the culverts. Marshall Branch is a FEMA studied stream in this location. As a result, the channel has calculated Base Flood Elevations (BFEs), and lettered cross-sections. Figure 2 shows the contributing drainage area for Marshall Branch at Trophy Club Drive. Figure 2 also compares the FEMA-effective and FNI-computed existing conditions of the 100-Year floodplain for Marshall Branch at Trophy Club Drive.

Erosion in channel

This alternative includes installation of a bridge with piers and channel excavation upstream and downstream of Trophy Club Drive. A bridge, approximately 500-feet in length, is needed to replace the existing 3-10'x8' box culverts to span across Marshall Branch. Trophy Club Drive will be raised approximately 6-feet in order for the bridge to pass the 100-Year storm event. This proposed improvement will provide approximately 0.8-feet of freeboard to the top chord of the roadway. NCTCOG *iSWM*[™] design guidance indicates that the crossing should include 2-feet of freeboard to the low chord of a bridge. During final design of the proposed improvements, modifications to grading, bridge height and hydraulic opening should be finalized to achieve this result or to determine if the criteria should be changed. Channel excavation upstream and downstream of Trophy Club Drive on the west side of the channel will provide additional valley storage, lowering the tailwater at Trophy Club Drive and removing the residential structures on the east side of Marshall Branch from the 100-Year floodplain. Typical cross sections can be seen in Exhibits 6 and 7 for the proposed excavation upstream and downstream of Trophy Club Drive. The OPCC for this alternative is approximately \$5.3 Million and is included as an appendix to this report. The proposed improvements can be seen in Figure 7.

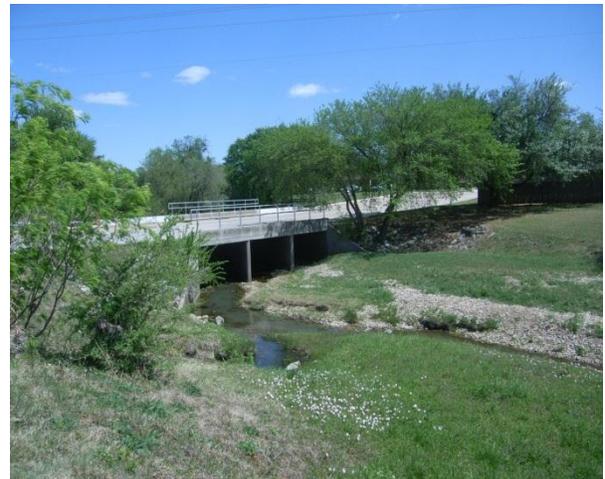
Sedimentation blocking culverts

As described in the existing conditions section of this report, sedimentation upstream of the crossing has occurred over time, partially blocking the existing opening and further reducing the hydraulic carrying capacity of the 3-8'x10' RCBs. Grading limits upstream of Trophy Club Drive serve to eliminate this blockage and to further reduce the width of the 100-Year floodplain between Trophy Club Drive and Highway 114. It is estimated that the upstream grading will remove eight (8) residential properties from the floodplain as shown on Figure 7. The total grading effort both upstream and downstream will remove a total of 15 structures from the floodplain; seven (7) structures will be removed due to the downstream grading and eight (8) structures due to the upstream grading.

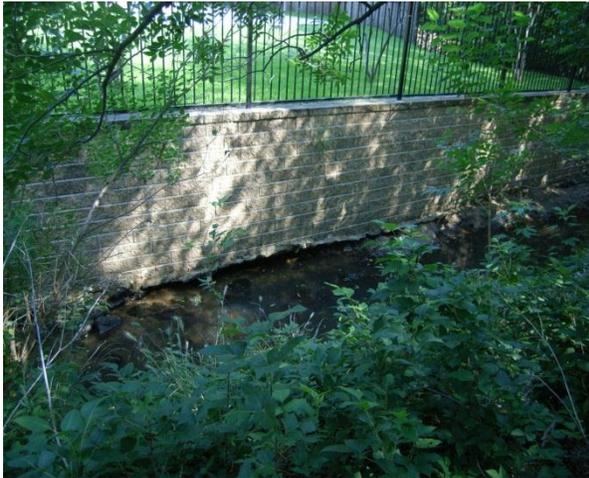
Undermined retaining wall

Because existing improvements are inconsistent and existing residential structures are located so close to the channel banks, a complete reconstruction of the channel is recommended for this focus area. Proposed improvements include a uniform channel section with vertical side slopes and a bottom width varying from 15-feet to 50-feet. The uniform section recommended is a structural concrete block wall from T.W. King Road upstream and approximately 3,000 linear feet to the northern edge of the golf course adjacent to Timberline Drive (see Figure 8). The three roadway crossings encompassed within these limits, Greenleaf Drive, Indian Creek Drive and T.W. King Road are also recommended for upgrade. The approximately 240 linear feet of Skyline (Indian) Creek, through the golf course between the upstream end of this Skyline (Indian) Creek focus area and the downstream end of the Fresh Meadows focus area, are not recommended for improvement. This 240 linear feet of channel is not limited by existing

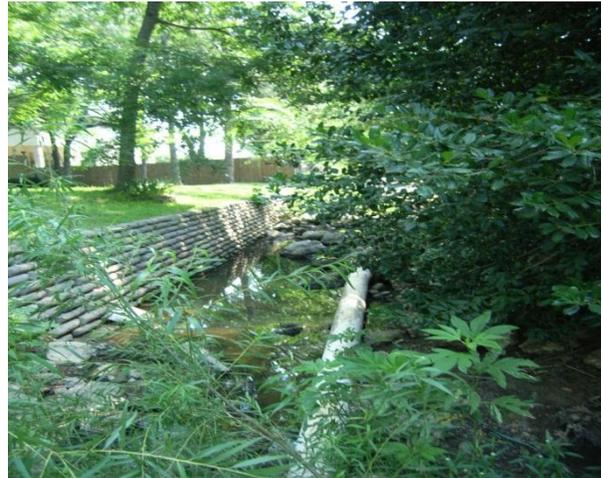
Exposed sanitary sewer

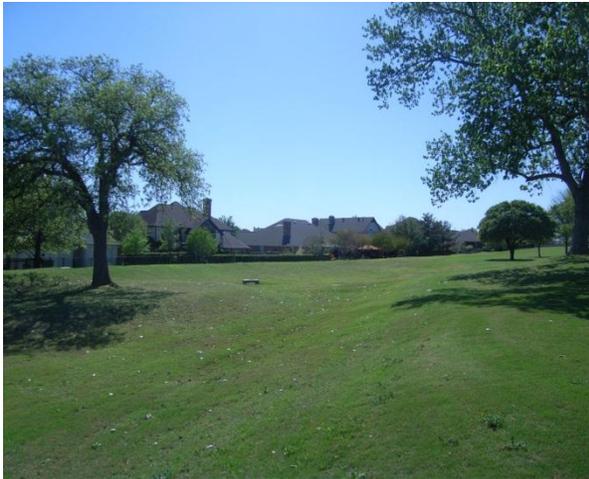
Information from Town staff and residents, obtained during the public meeting indicates that runoff from The Knoll previously exceeded the capacity of the surface drainage features in the golf course and entered residential structures on the west side over Overhill Drive north of Timber Ridge Drive. Remediation efforts were constructed in 2006 with additional grading of the golf course and of the existing detention pond. However, manhole covers along Timber Ridge Drive continue to be forced open by excess flow during heavy rain events, causing

significant runoff to drain to the intersection of Timber Ridge Drive and Skyline Drive where the intersection becomes inundated. Excess drainage at the flooded intersection overtops the south curblin and inundates the residences at 4 and 6 Skyline Drive before discharging into Skyline (Indian) Creek. Movement of the manhole covers during storm events confirms calculations indicating that the existing system is undersized for design storm events.

Photo showing existing detention pond with 3' inlet

The recommended improvements consist of approximately 300 linear feet of 30-inch pipe on Timber Ridge Drive and 500 linear feet of 36-inch pipe on Skyline Drive and Indian Creek Drive as described above and shown graphically on Figure 9. The OPCC for these proposed improvements is \$240,000 and is included as an appendix to this report. The OPCC assumes the pavement repair will be limited to trench width and does not include the cost of complete pavement repair.

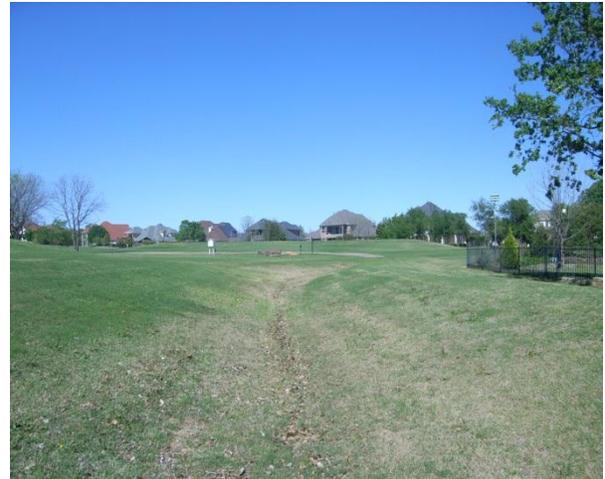
Existing swale leading to pond

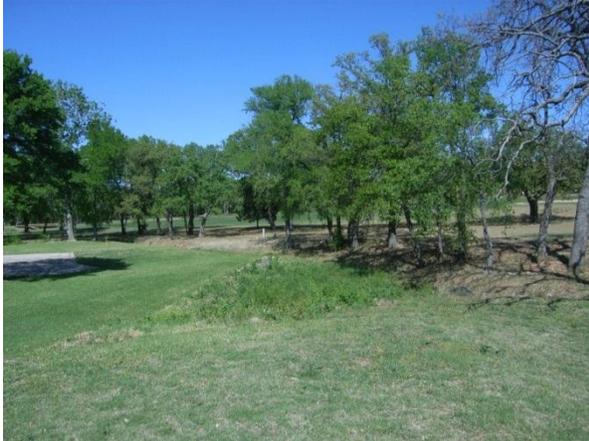
Based on comments received at the public meeting from adjacent residents, it was discovered that several homes northwest of the pond experience high water and the potential for residential inundation during rain events. A site investigation by the study team revealed a natural swales running behind the homes from 218 through 222 Fresh Meadows Drive and Fresh Meadows Court and outfalling into the golf course pond. The pond has an outfall structure comprised of 2-24-inch diameter High Density Polyethylene (HDPE) pipes and an overflow path draining to the swale behind the properties at 224 and 226 Fresh Meadows

Existing overflow swale

Pond outfall modifications are proposed to control normal pool elevations in the golf course pond. As noted earlier, the current pond grading and outfall configuration do not allow significant storage of rainfall flows prior to overtopping the spillway. In addition, the current outfall structure of 2-18-inch grate inlets from the pond is undersized to convey design flows without engaging the spillway, the low portion of the bank on the north side of the pond. The grading between the spillway and the adjacent residential structures at 222 and 224 Fresh Meadows Court does not direct runoff away from the residences and toward the outfall channel. The finished floor elevations at 222 and 224 Fresh Meadows Court are approximately at the same elevation as the top of bank on the downstream side of the pond. As a result, overtopping in the pond places the adjacent homes at risk of inundation. Resident information provided at the public meeting confirms these calculations. Calculations indicate that a 2-Year return event storm will engage the spillway of the pond. In addition, a 25-Year return event storm may result in flooding of adjacent residential structures.

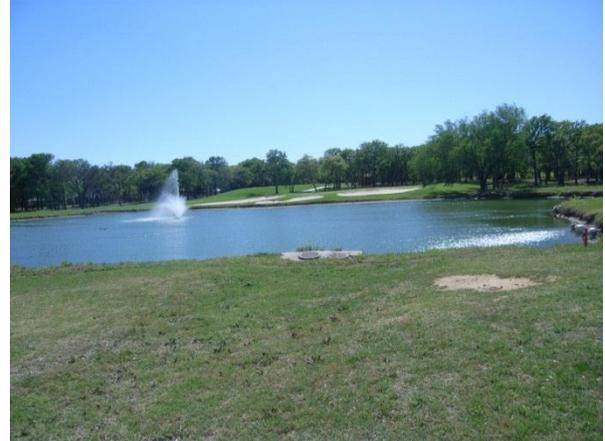
Existing outfall structure (2-24-inch HDPE) and overflow

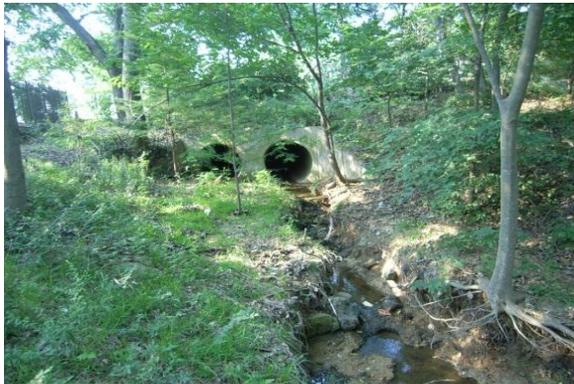
The channel encompasses a small earthen section capable of carrying lower return event flows. This low-flow channel is in a state of downcutting (lowering flowline and widening banks) along

Channel downcutting

Proposed improvements for Cypress Creek include installing approximately 1,500 linear feet of gabion baskets in specific point repair locations along the banks of the channel. The gabion baskets would be approximately 6 feet tall and would leave a natural channel bottom in place. In order to implement the proposed improvements, a detailed geomorphological and geotechnical investigation, along with design level survey is recommended. The OPCC for this conceptual improvement scenario is approximately \$1.3 Million and is included as an appendix to this report.

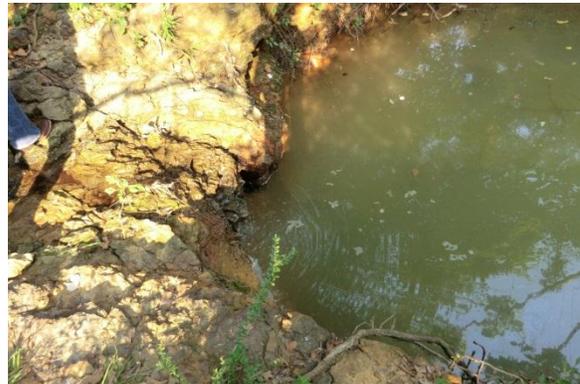
Knickpoint migrating in the upstream direction

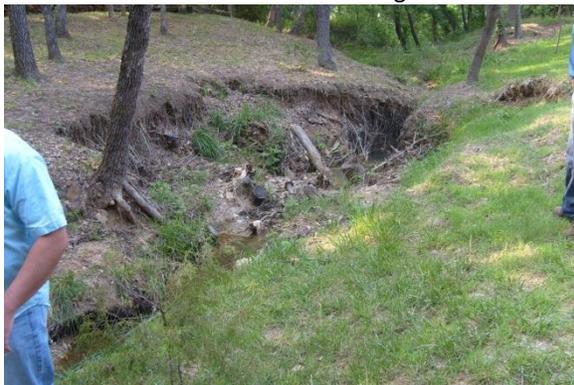
Channel incision, knickpoint and slow moving creep

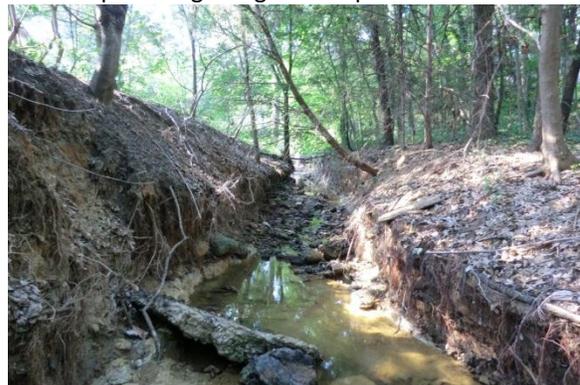
the majority of the length observed. Areas that were incised (width/depth ratios less than 10) had generally steep banks and were undercut in some locations. The creek banks on the outside of meanders were scoured and near-vertical. Tree roots were exposed, indicating bank erosion and channel widening. Multiple knickpoints (headcuts) were observed on the channel bed. Knickpoints are natural drops in elevation which are characteristic of channels that are actively downcutting (see Exhibit 5). Bank failures in the form of rotational slides (slumps) were observed. Leaning trees on the creek banks indicate slow moving creep failures. Causes of stream bank failure may include improper drainage from residential properties, existing geologic conditions and geotechnical properties of the slope, and removal of the bank toe following channel downcutting and/or widening. Prior to design of bank stabilization improvements, it is recommended that a detailed geotechnical investigation be conducted to determine the cause (or causes) of slope failures. The instabilities observed in the unnamed creek did not appear to pose an immediate threat to existing municipal infrastructure.

Incised channel, toe erosion, creeps, leaning trees, exposed roots

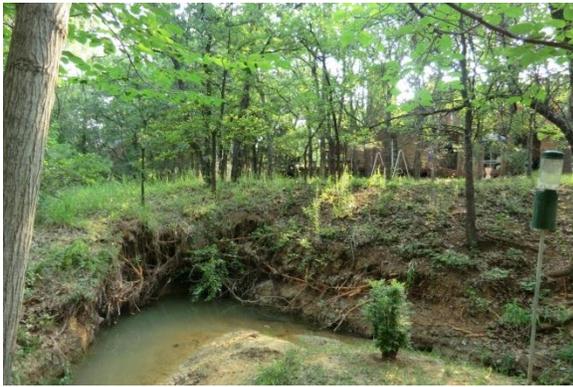
Bank scour on a meander

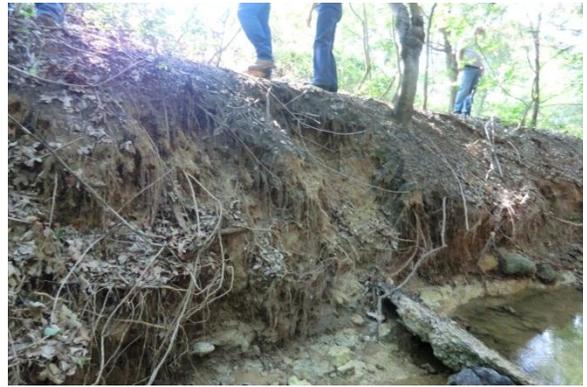
Vertical banks, soil loss, exposed roots
